ENIQ 2nd PILOT STUDY – DEFECT ASSESSMENT AND DESTRUCTIVE EXAMINATION REPORT

ENIQ Report nr. 32

European Network for Inspection and Qualification

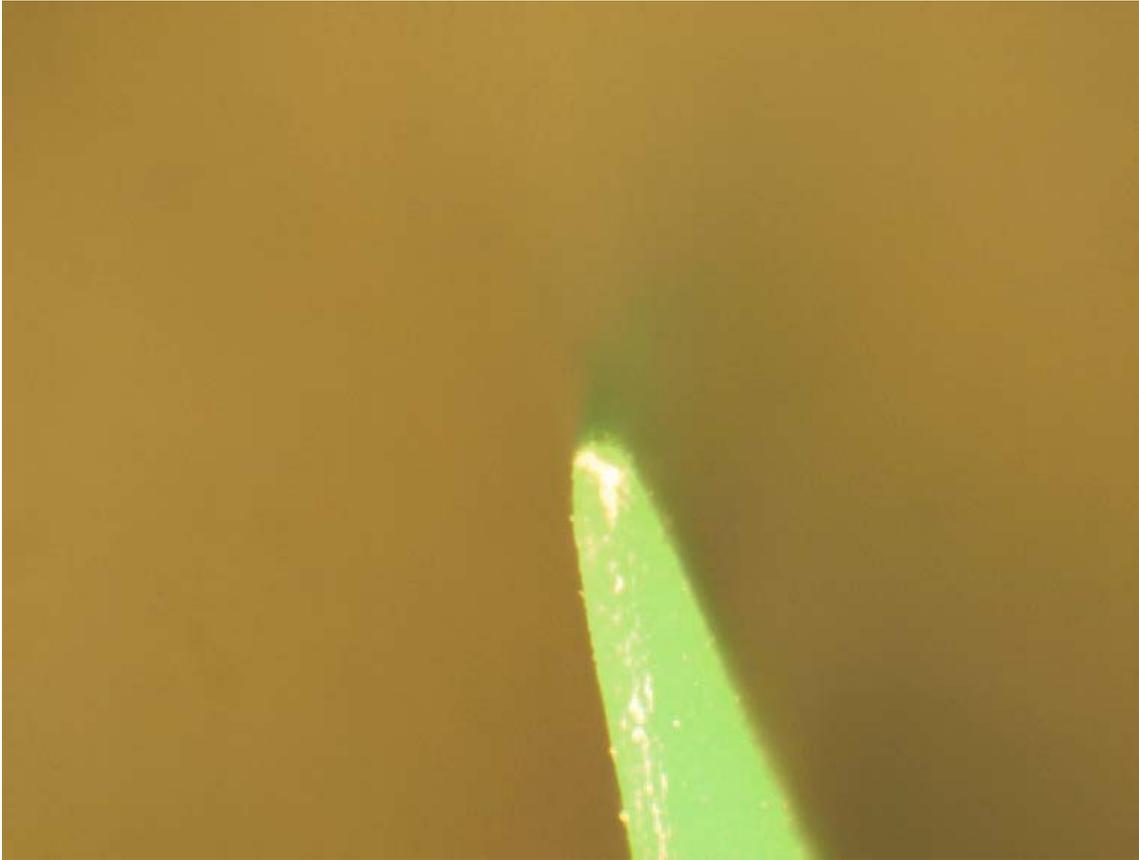
Figure 2 – Photograph of replica of defect 7

The investigation of replicas under microscope has confirmed that the crack tips are sharp, i.e. that the tip radius is small. Figure 2 shows a typical example for defect 7. The photographs of all 6 surface breaking defect replicas are presented in Appendix 1. The opening angles range between 12° (defect 5) and 16° (defect 4).

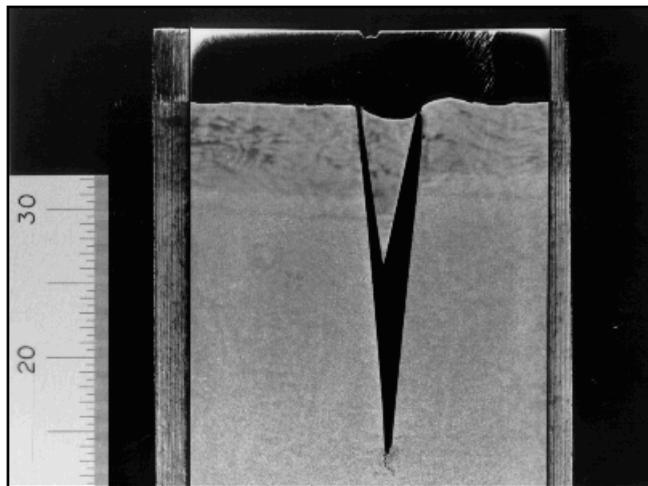
Figure 3 – Wedge in the near surface defect to prevent cladding penetration

The application of the cladding layer, however, may have caused penetration through melting at the “shallow edge” of the defect facing the interface between base metal and cladding. This penetration may reduce the “as built” values. In order to avoid having melted cladding penetrating into the defect, wedges were placed in the openings of the then surface breaking defects before the cladding was applied (as illustrated in Figure 3, taken from another project).

As no destructive examination of the near surface defects has been performed, the effect of the cladding would have to be estimated based on experience. The Nuclear Research Institute (NRI) Řež has destructively examined the same type of near surface defects in other RPV components⁽⁹⁾. Welding experts have compared the NRI case with the ENIQ nozzle assembly 21 and estimated the penetration, based on materials and welding procedures used in the two cases. For the strip cladding used the estimated penetration is 1.5 mm.

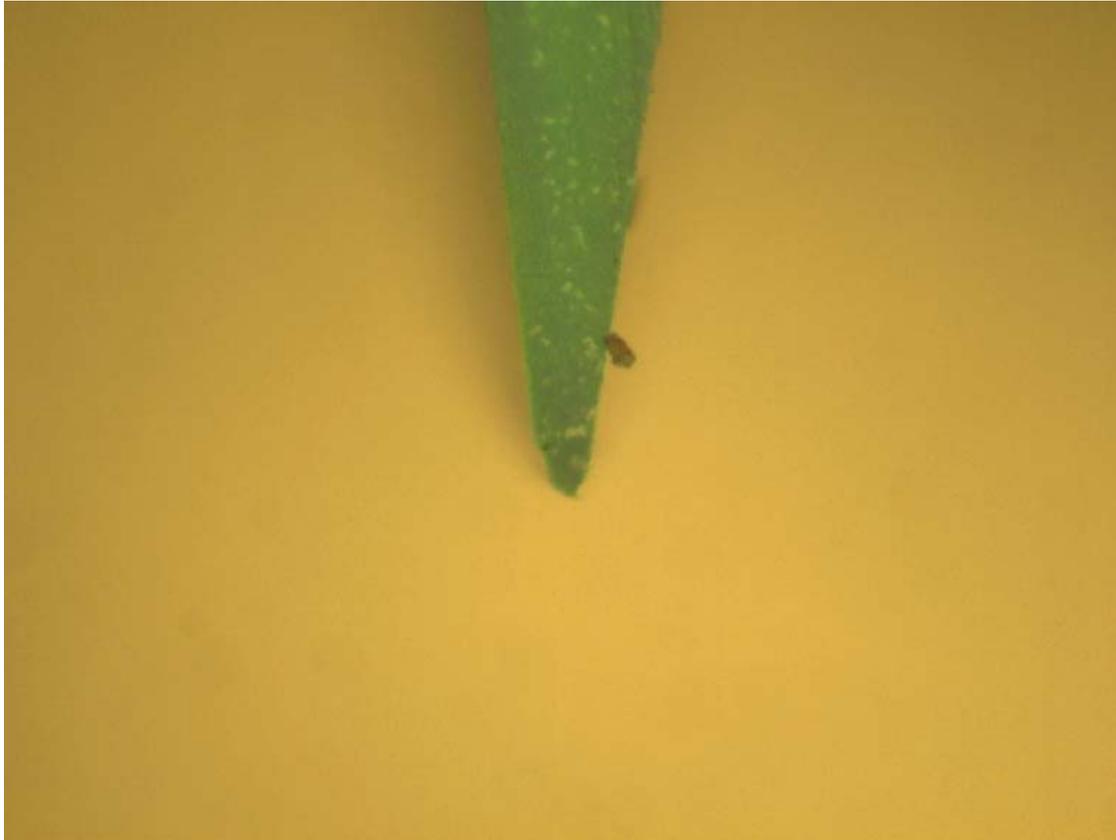
Figure 4 – Photograph of replica of defect 1

The investigation of replicas under microscope has confirmed that the crack tips are sharp, i.e. that the tip radius is small. Figure 4 shows a typical example for defect 1. The photographs of all near surface defect replicas (except for defect 8) are presented in Appendix 1. The opening angles range between 11° (defect 10) and 16° (defect 1).

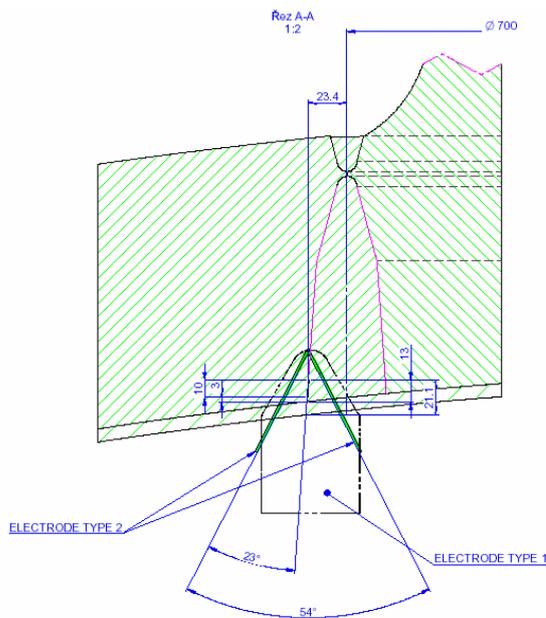
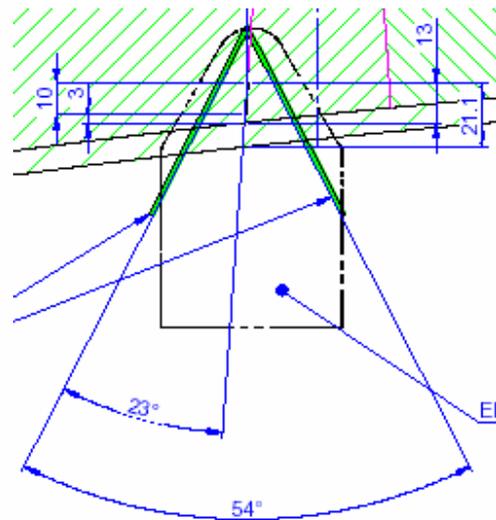
Fig. 3.3.1 A part of the drawing for the defect No. 13 sample cut out by EDM machine

The sample cut out from Nozzle 21 also was used to determine the relative angle between the two weld fusion faces of the weld. Both fusion faces in the weld of the Nozzle test block N21 have according to the manufacturing drawing a nominal inclination angle of 4° (equal to the LOF type defect tilt) relative to the weld centre line, i.e. the nominal angle between bevels is 8° . During destructive examination this value was confirmed at the position of the LOF defect No.13, as follows:

- The bevel/tilt angle of 4° relative to the weld centre line can be measured and verified on appropriate sample by comparison of 3D CAD drawing of the Nozzle block 21 with a developed procedure for sample cut out using EDM electrodes (see Fig 3.3.1) and an “as built” value measured on the sample BC at section M3
- The bevel/tilt angle value determined on the sample BC at section M3 should be equal to the difference of two angles: $4^\circ = 27^\circ - 23^\circ$ (see also Fig 3.3.1)
- The angle difference of the sample edges is 54.3° . It very well corresponds to the angle of 54° on Fig 3.3.1b
- Similarly the appropriate angles of values of 23° (see Fig 3.3.1b) and 24° differ only slightly on the level of fabrication/measurement tolerance (EDM machine, machining of sample).

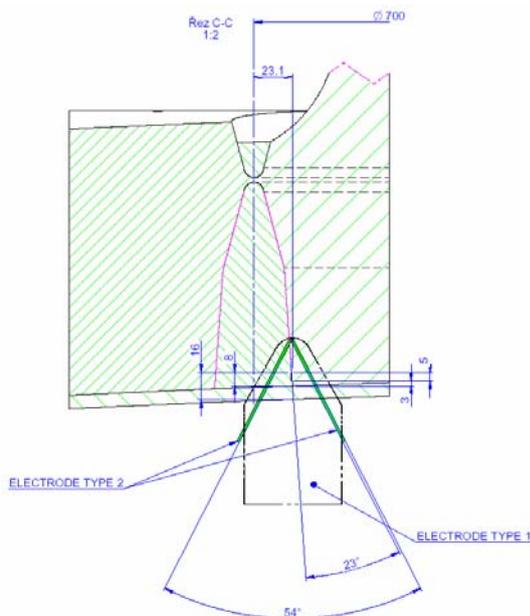
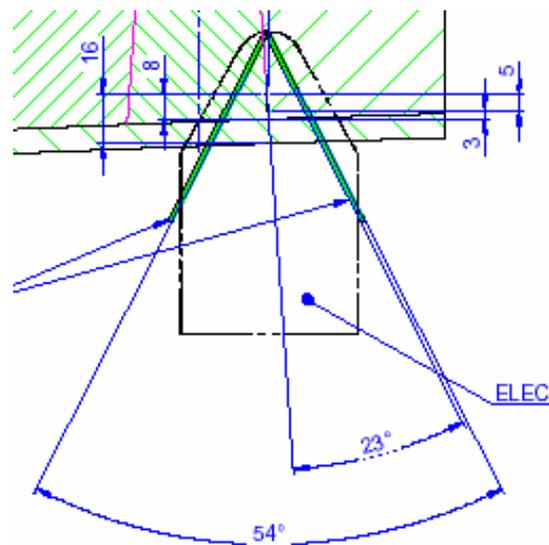
Fig. 4.3.1 A part of the drawing for the defect No. 16 sample cut out by EDM machine

- The angle difference of the sample edges is $53,8^\circ$. It very well corresponds to the angle of 54° on Fig 4.3.1b. The angle difference of the sample edges when measured on sections M10, M12 or M09, M11 is in both cases 55.9° .

- Similarly the appropriate angles of values of 23° (see Fig 4.3.1b) and $21,5^\circ$ or similarly 21.1° (M10, M12) and 21.7° (M09, M11 - (see Tab. 4.1) differ only slightly on the level of fabrication/measurement tolerance (EDM machine, machining of sample).

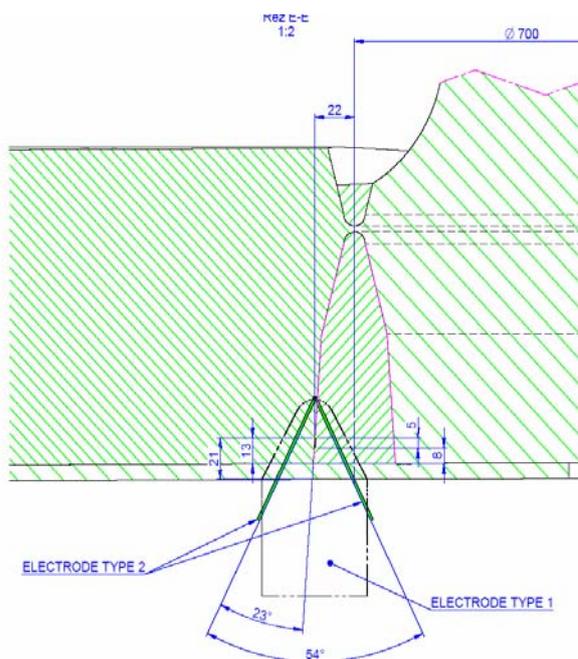
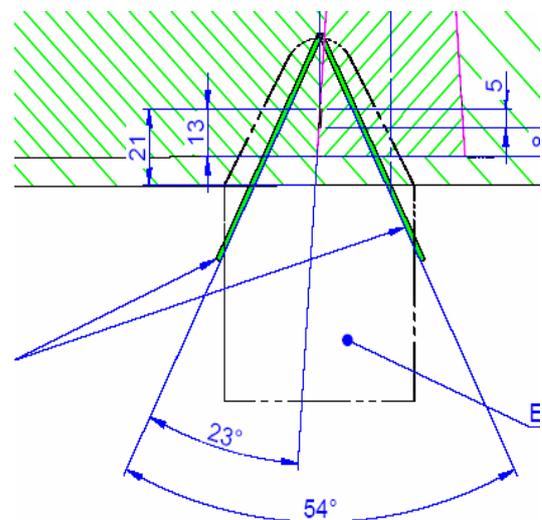
Fig. 5.3.1 A part of the drawing for the defect No. 17 sample cut out by EDM machine

- The angle of the coupon segment edges is 53.3° , 55.4° (at Sections M10, M12), 55.3° (at Sections M09, M11). It corresponds to the angle of 54° on Fig 5.2.1b within expected tolerance.

- Similarly the appropriate angles of values of 23° (see Fig 5.2.1b) and $23,8^\circ$ (or 25.3° (at Sections M10, M12), 25.6° (at Sections M09, M11) differ with the fabrication/measurement tolerance (EDM machine, machining of coupon segment).
