ENIQ 2nd PILOT STUDY – DEFECT ASSESSMENT AND DESTRUCTIVE EXAMINATION REPORT

ENIQ Report nr. 32

European Network for Inspection and Qualification

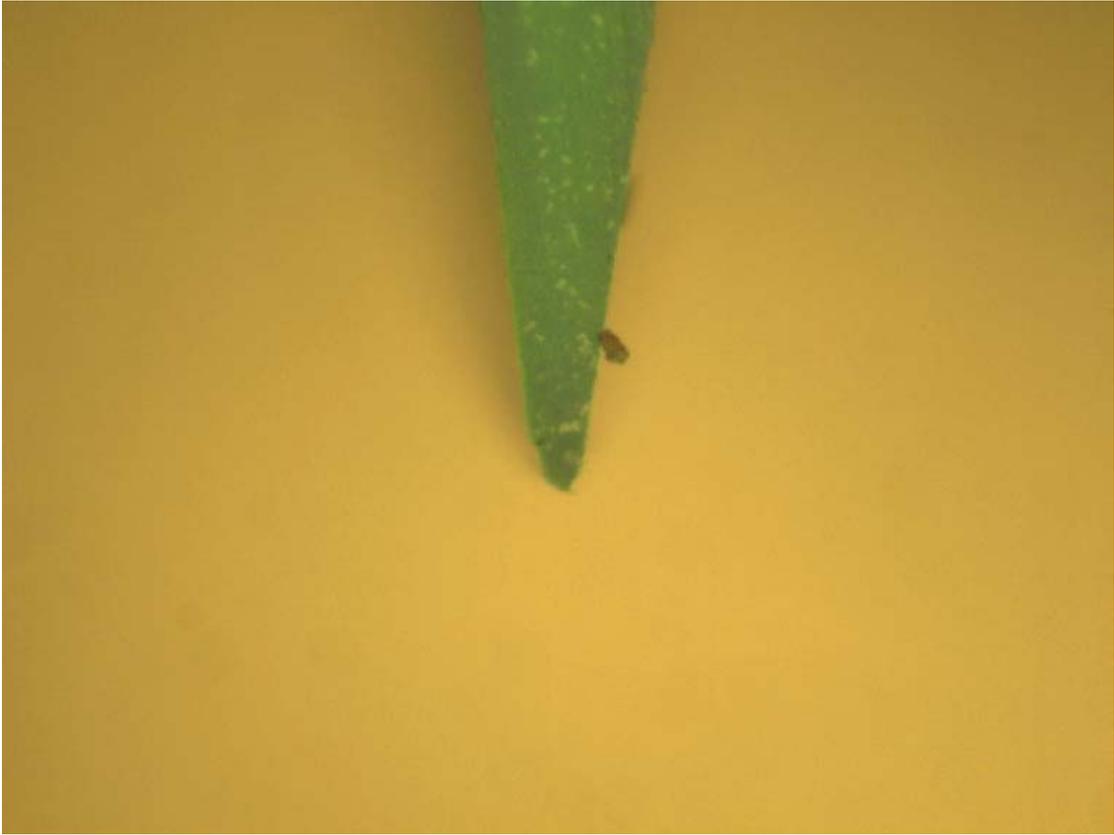
Figure 1 – Photograph of replica of defect 1

The investigation of replicas under microscope has confirmed that the crack tips are sharp, i.e. that the tip radius is small. Figure 4 shows a typical example for defect 1. The photographs of all near surface defect replicas (except for defect 8) are presented in Appendix 1. The opening angles range between 11° (defect 10) and 16° (defect 1).

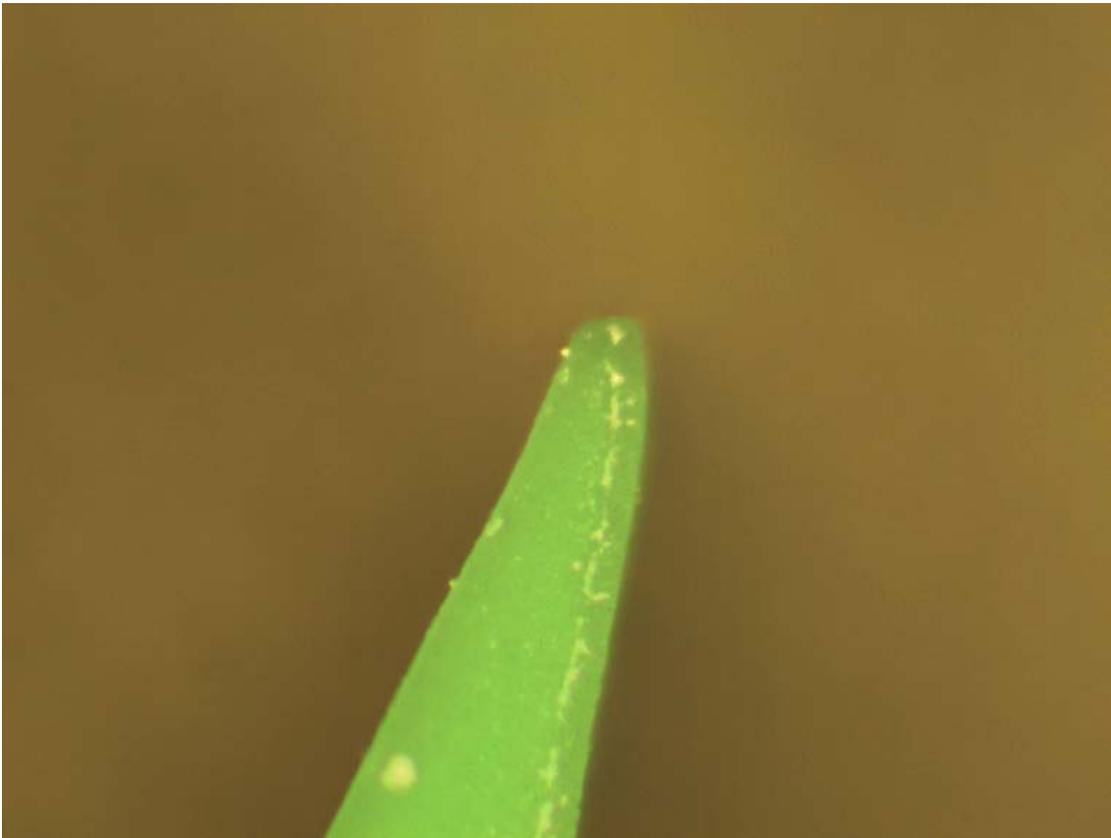
Figure 4 – Photograph of replica of defect 4

The investigation of replicas under microscope has confirmed that the crack tips are sharp, i.e. that the tip radius is small. Figure 2 shows a typical example for defect 7. The photographs of all 6 surface breaking defect replicas are presented in Appendix 1. The opening angles range between 12° (defect 5) and 16° (defect 4).
